Re: Rainier Commons Phase IIa Close-Out Report - Response to EPA's Request for Additional Information

Rainier Commons Exterior Paint Removal Project

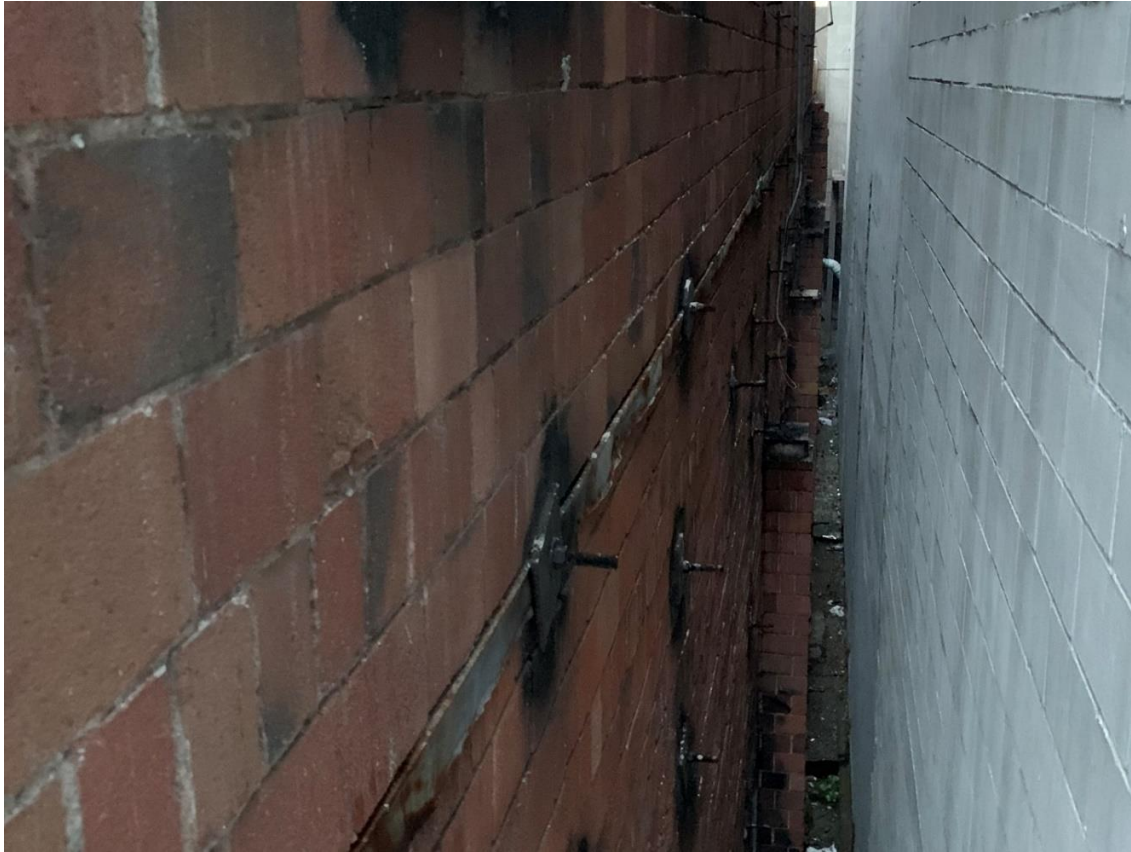
In contrast, the horizontal, grey-colored band shown in the visual inspection photographs for grids 340, 356, and 387 is non-porous, galvanized steel flashing. The metal flashing runs along the length of the building, corresponding to the second-floor diaphragm inside the building. The flashing is presumed to have been installed during original construction.

All paint was removed from the metal flashing during the Phase IIa work. The metal flashing is shown in the photograph below. The photograph was taken on October 16, 2019.
